IBM Flex System x440 Compute Node
Types 7917 and 2584
Installation and Service Guide

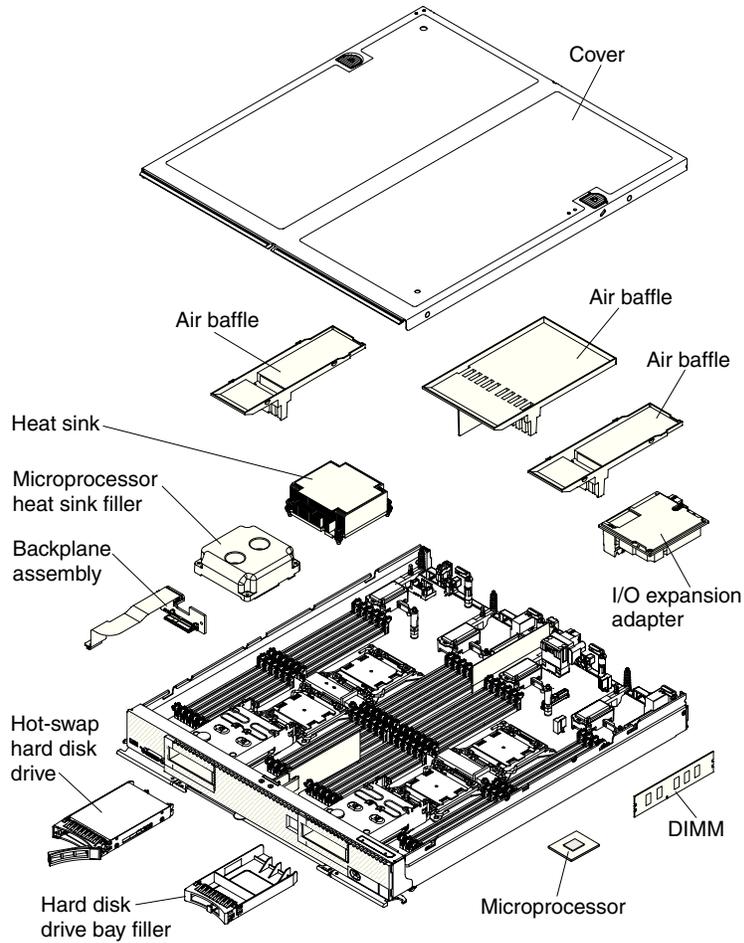
Use this information to locate the major components on the compute node. The major components of the compute node include field replaceable units (FRUs), customer replaceable units (CRUs), and optional devices.

The following illustration shows the major components of the compute node.

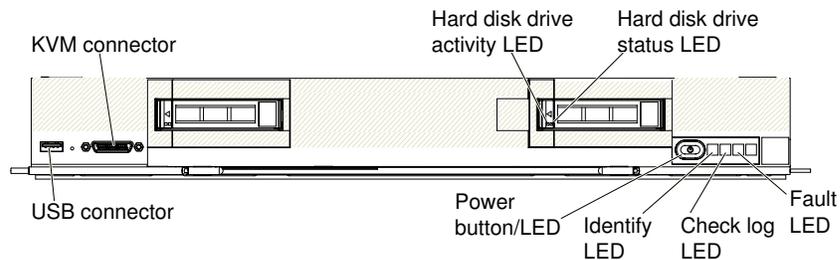
The following illustration identifies the buttons, connectors, and LEDs on the control panel.

Fault LED

When this yellow LED is lit, it indicates that a system error has occurred in

the compute node. In addition, the fault LED on the chassis system LED panel is lit. You can check the CMM event log to determine the source of the condition. For more information, see "Viewing event logs without restarting the compute node" on page 64 "Viewing event logs without restarting the compute node" on page 56. See "Light path diagnostics LEDs" on page 59 for more information about the LEDs on the compute node.

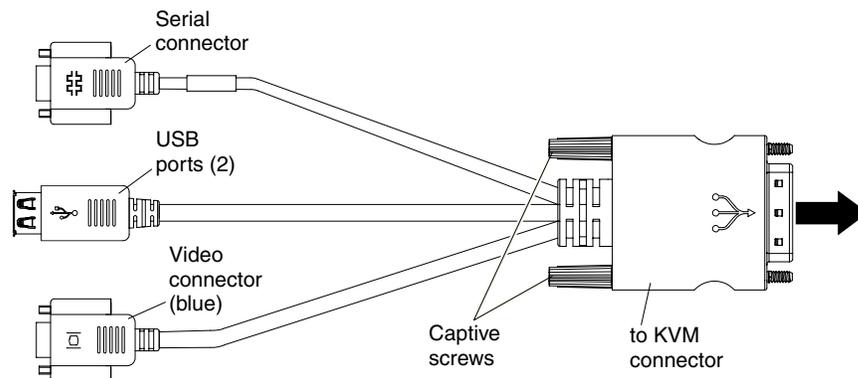
Use the console breakout cable to connect external I/O devices to the compute node. The console breakout cable connects through the KVM connector (see “Compute node controls, connectors, and LEDs” on page 10). The console breakout cable has connectors for a display device (video), two USB connectors for a USB keyboard and mouse, and a serial interface connector.

The following illustration identifies the connectors and components on the console breakout cable.

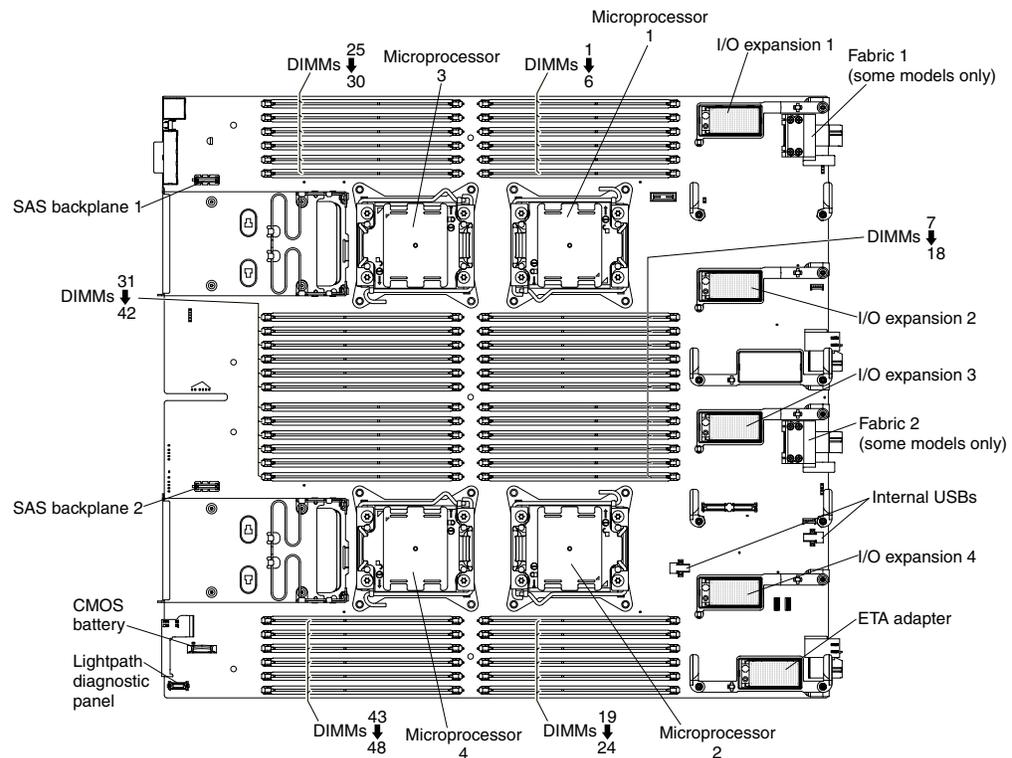
Use this information to locate compute node system-board components and connectors for optional devices.

The following illustration shows the system-board components, including connectors for user-installable optional devices, in the compute node.

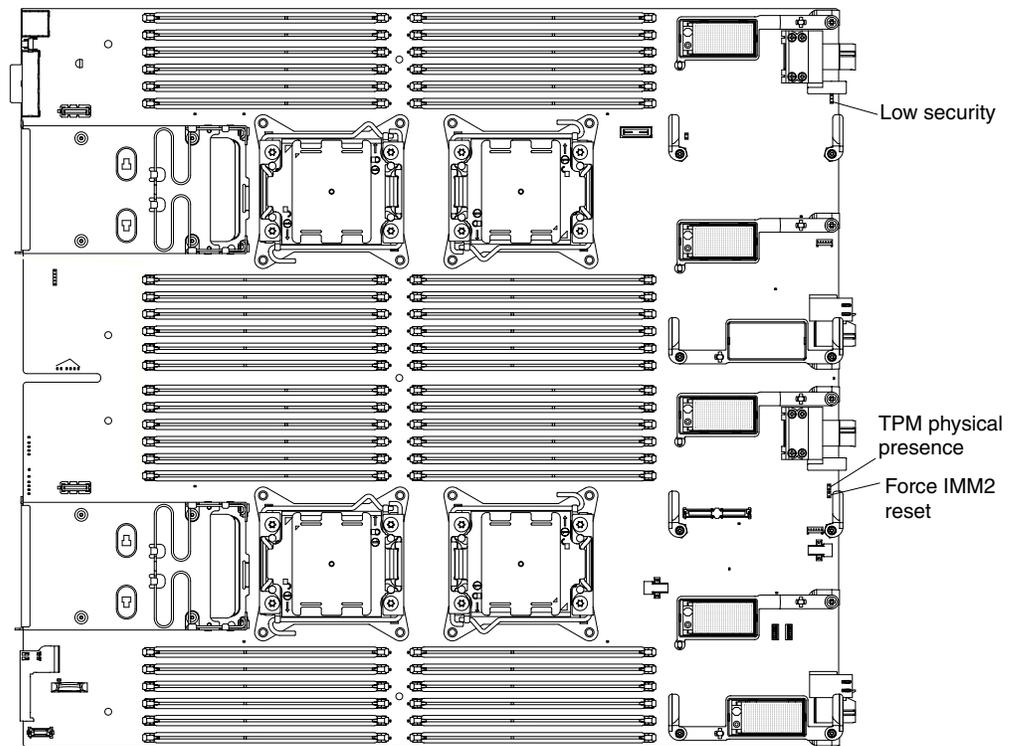
The following illustration shows the locations of the jumpers on the system board.

The following table describes the function of each jumper on the system board.

Jumper number	Description
Force IMM Reset (J12)	For debug purposes only.
Low Security (J9101)	Three-pin jumper block. The default position are pins 2 and 3 (allow only signed IMM2 to be flashed). Move the jumper to pins 1 and 2 to to remove the security check (low security).
Trusted Platform Module (TPM) physical presence (J6)	Two-pin jumper. The default is no jumper. Place a jumper on pins 1 and 2 to indicate a physical presence to the IMM2 TPM chip.

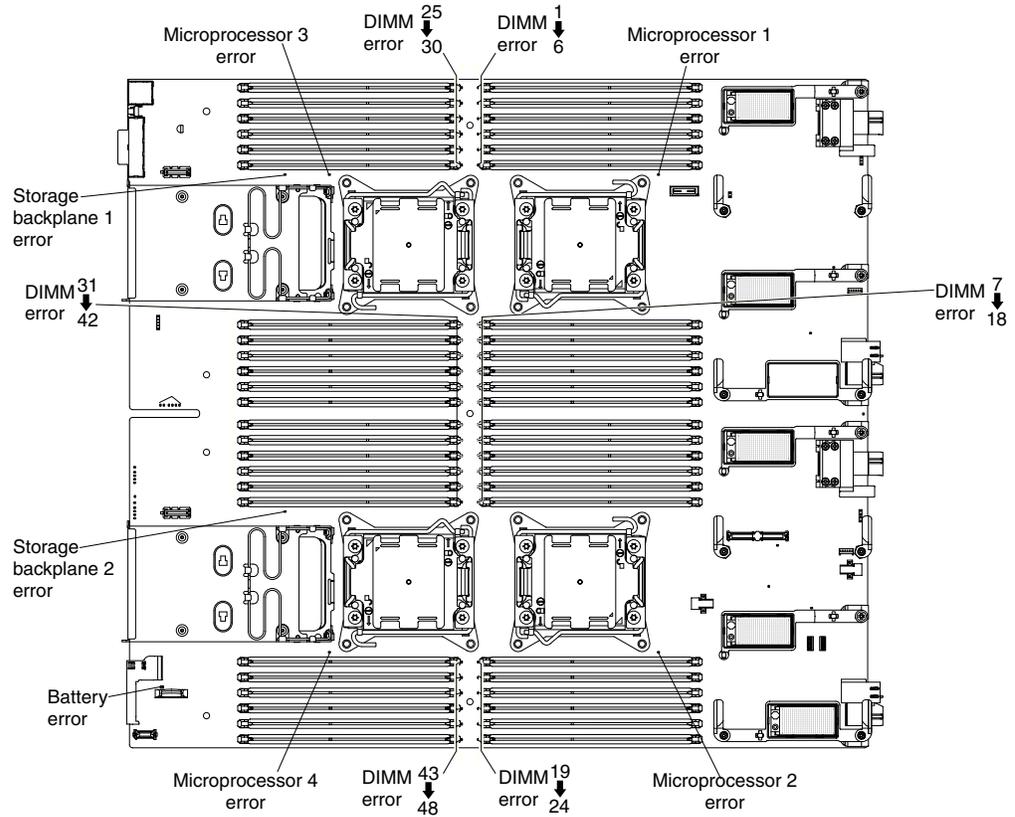
The following illustration shows the location of the LEDs on the system board.

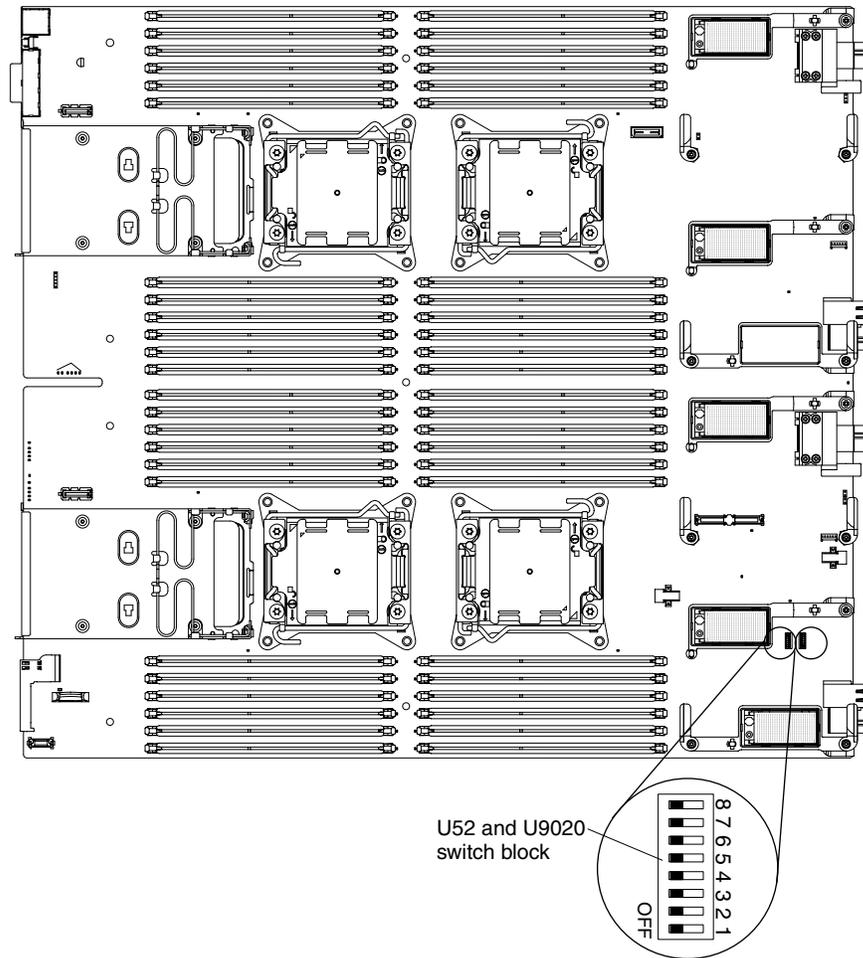
The following illustration shows the location of the switch block on the system board.

The following table describes the functions of the switches on switch block SW3.

Switch number	Description	Switch setting	Definition
U52-1	Password override	The default position is Open.	Changing this switch to the Closed position overrides the power-on password.
U52-2	Trusted Platform Module (TPM) physical presence	The default position is Open.	Changing this switch to the Closed position indicates a physical presence to the TPM.
U52-3	Real time clock (RTC) reset	The default position is Open.	Changing this switch to the Closed position resets the RTC. A momentary toggle is all that is required. To avoid excessive CMOS battery drain, do not leave this switch in the Closed position.

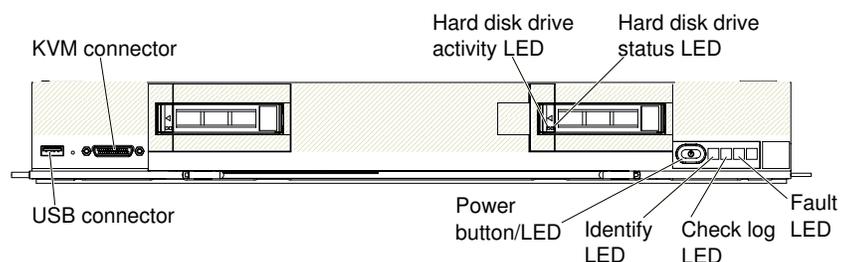
1. Look at the control panel on the front of the compute node.

- If the check log LED is lit, it indicates that an Automatic BIOS Recovery has occurred. The compute node will start by using the backup UEFI image.

- If the fault LED is lit, it indicates that an error has occurred; view the light path diagnostics panel and LEDs to isolate the failing component.
2. To view the light path diagnostics LEDs, select one of the following procedures:

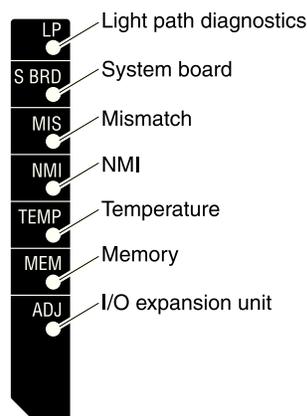
The following illustration shows the LEDs on the light path diagnostics panel.

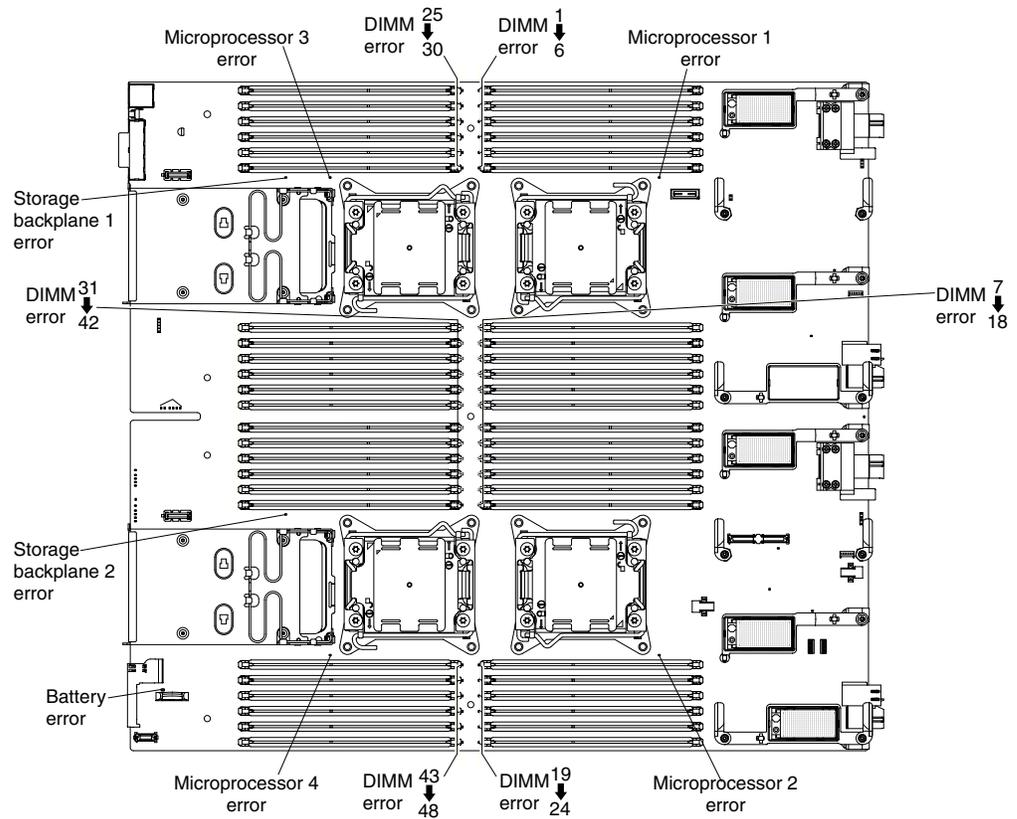
The following illustration shows the locations of the light path diagnostics LEDs on the system board.

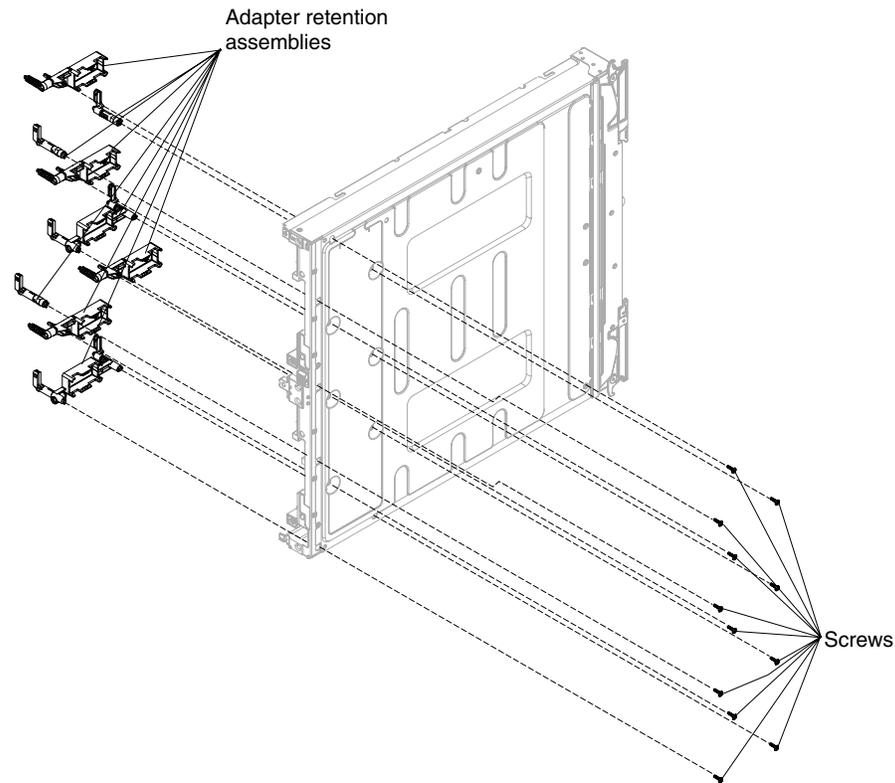
To remove the adapter-retention assembly, complete the following steps.

1. Remove the cover (see “Removing the compute node cover” on page 498).
2. Remove the air baffles.
3. If necessary, remove the I/O expansion adapters (see “Removing an I/O expansion adapter” on page 524).
4. Carefully place the chassis on its side with the front handle side up.
5. Using a T9 Torx screwdriver, remove the three screws that secure the adapter-retention assembly.
6. Lift the adapter-retention assembly from the system board.
7. Carefully return the chassis to the bottom-side-down orientation.

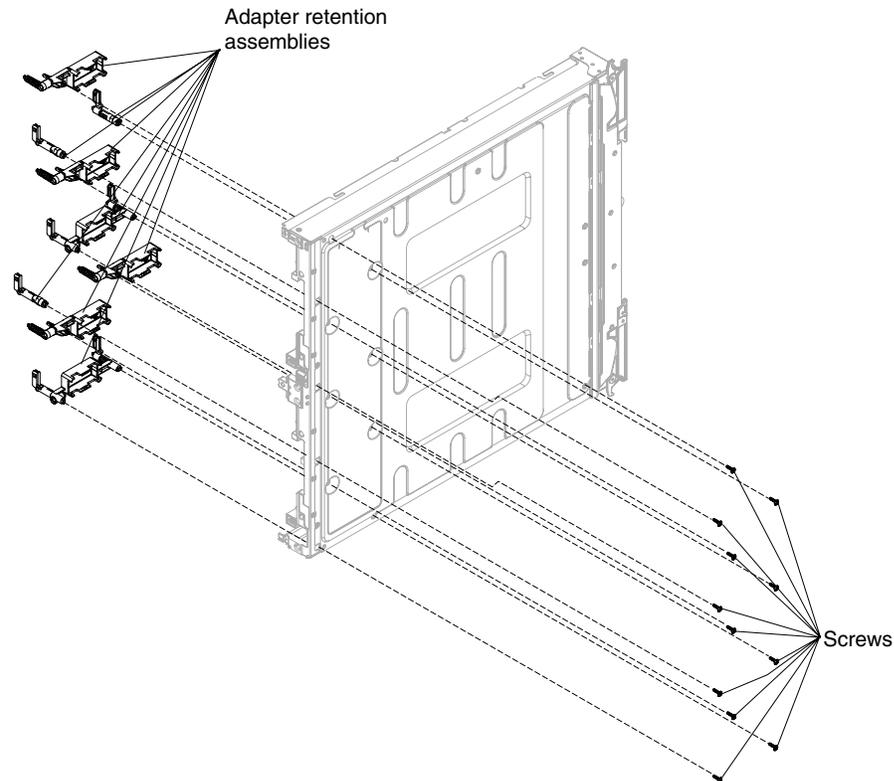
To install the adapter-retention assembly, complete the following steps.

1. Remove the cover (see “Removing the compute node cover” on page 498).
2. Remove the air baffles.
3. Carefully place the chassis on its side with the front handle side up.
4. Align the adapter-retention assembly on the system board.
5. Using a T9 Torx screwdriver, install the screws that secure the adapter-retention assembly.
6. Carefully return the chassis to the bottom-side-down orientation.
7. Install the I/O expansion adapters, if you removed them (see “Installing an I/O expansion adapter” on page 525).
8. Install the air baffles.

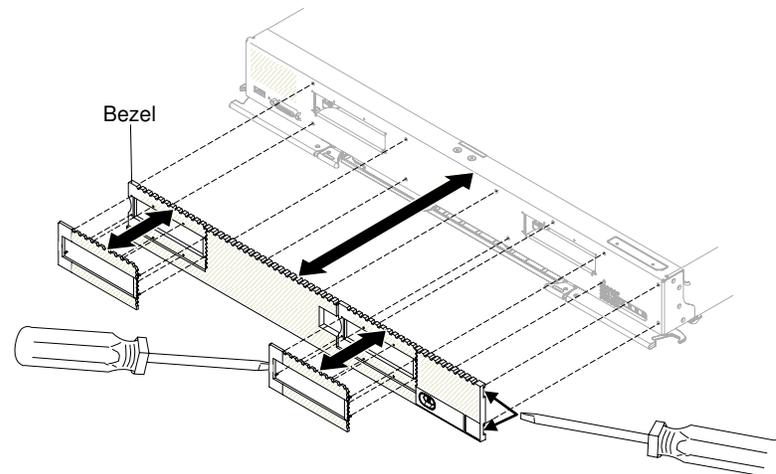
To remove the bezel, complete the following steps.

1. Use a flat-blade screwdriver to carefully pull the bezel from the compute node.
2. Lift the bezel from the compute node.

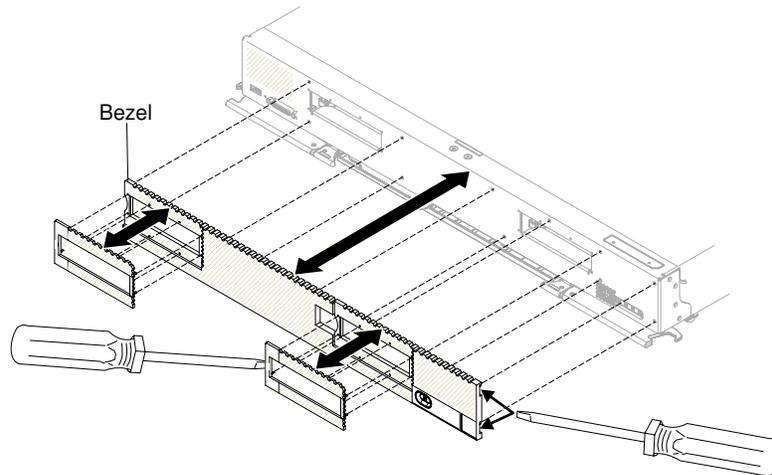
To install the bezel, complete the following steps.

1. Position the bezel on the front of the compute node.
2. Press the bezel securely against the chassis.

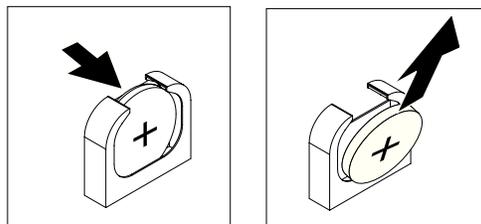
1. Remove the cover (see “Removing the compute node cover” on page 498).
2. Locate the CMOS battery on the system board (see “System-board connectors” on page 16).
3. If a cover is over the CMOS battery, remove the cover.
4. Pivot the CMOS battery toward the middle of the compute node.

5. Lift the CMOS battery from the socket.

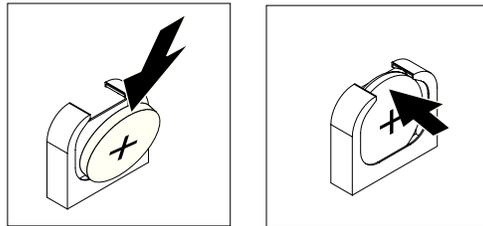
1. Remove the cover (see “Removing the compute node cover”).
2. Follow any special handling and installation instructions that come with the CMOS battery.
3. Locate the CMOS battery socket on the system board (see “System-board connectors” on page 16).
4. Orient the CMOS battery so that the positive (+) side faces in toward the center of the compute node.

5. Pivot the CMOS battery so that you can insert it into the bottom of the socket.
6. As you slide the CMOS battery into place, press the top of the CMOS battery into the socket.
7. If you removed a cover from the battery, replace the cover.

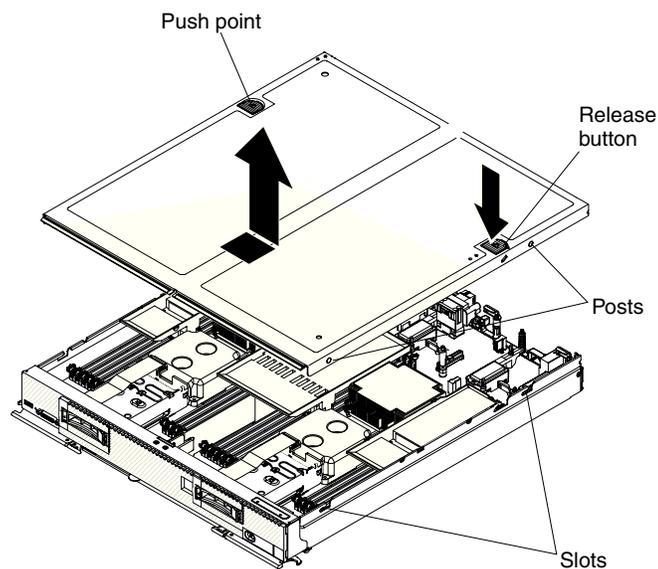
1. Press on the release button and the push point at the same time and slide the cover toward the rear of the compute node.
2. Lift the cover away from the compute node.

3. Lay the cover flat or store it for future use.

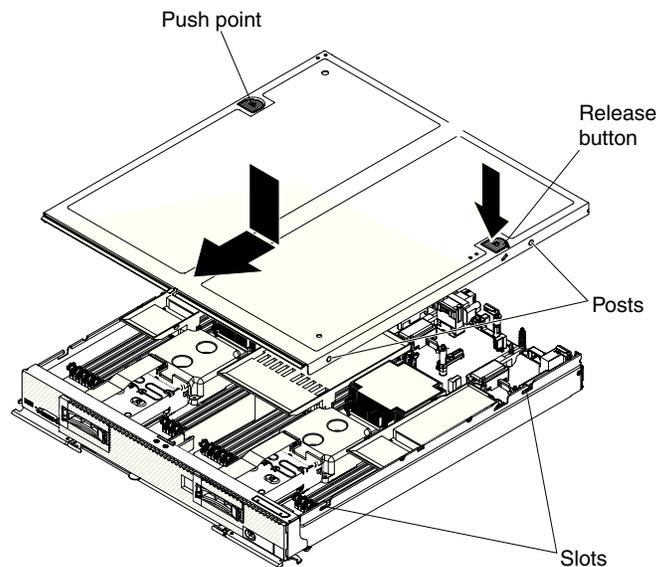
1. Carefully lay the compute node on a flat, static-protective surface, orienting the compute node with the bezel pointing toward you.
2. Orient the cover so that the posts on the inside of the cover slide into the slots on the compute node.

3. Hold the front of the compute node and slide the cover forward to the closed position, until it clicks into place.

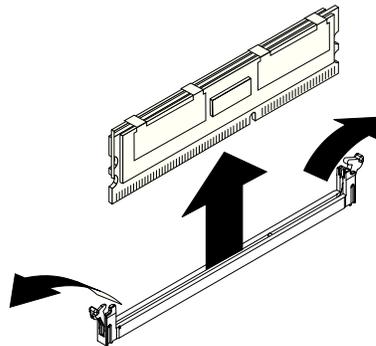
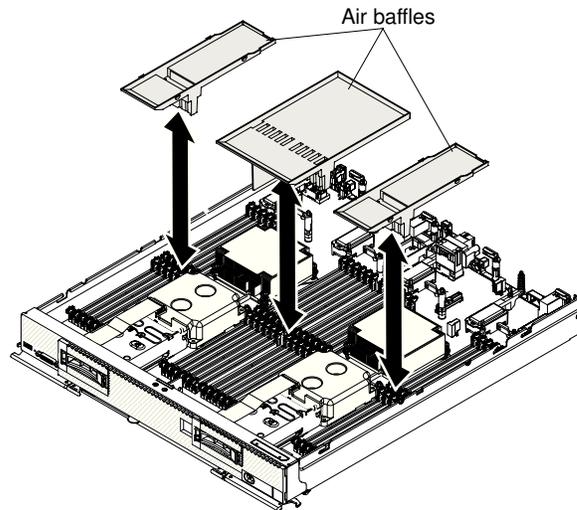
To remove a DIMM, complete the following steps.

1. Remove the cover (see “Removing the compute node cover” on page 498).
2. Remove the air baffle that is installed over the DIMM connector.

3. Locate the DIMM connectors (see “System-board connectors” on page 16). Determine which DIMM you want to remove from the compute node.

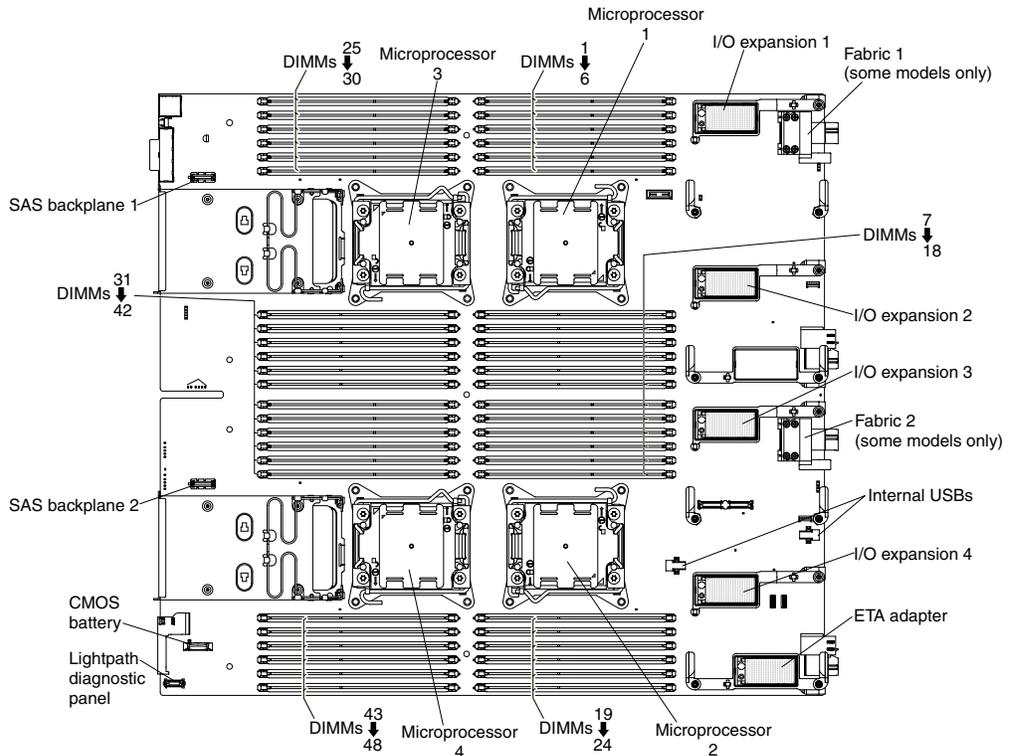
The compute node has a total of 48 dual inline memory module (DIMM) connectors. The compute node supports low-profile (LP) DDR3 DIMMs with error-correcting code (ECC) in 4 GB, 8 GB, 16 GB and 32 GB capacities.

The following illustration shows the system-board components, including the DIMM connectors.

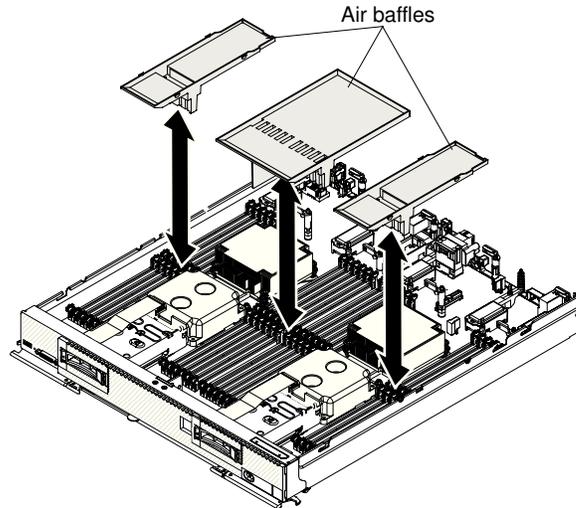
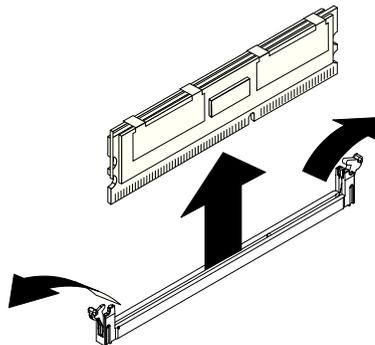
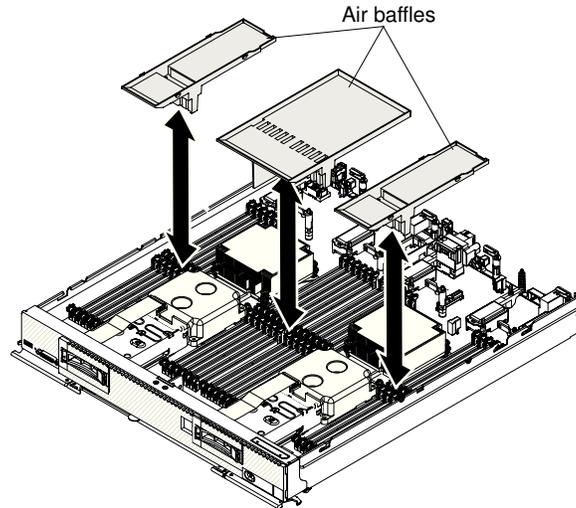
1. Remove the cover (see “Removing the compute node cover” on page 498).
2. Read the documentation that comes with the DIMM.
3. Remove the air baffle installed over the DIMM connector.

4. Locate the DIMM connectors (see “System-board connectors” on page 16). Determine which DIMM connector you want to install the DIMM in.
5. Touch the static-protective package that contains the DIMM to any *unpainted* metal surface on the IBM Flex System chassis or any *unpainted* metal surface on any other grounded rack component in the rack in which you are installing the DIMM for at least 2 seconds; then, remove the DIMM from its package.

6. Make sure that both retaining clips on the DIMM connector are in the open position.
7. Turn the DIMM so that the DIMM keys align correctly with the DIMM connector on the system board.
Attention: To avoid breaking the retaining clips or damaging the DIMM connector, handle the clips gently.
8. Press the DIMM into the DIMM connector. The retaining clips lock the DIMM into the connector.
9. Make sure that the small tabs on the retaining clips engage the notches on the DIMM. If there is a gap between the DIMM and the retaining clips, the DIMM has not been correctly installed. Press the DIMM firmly into the connector, and then press the retaining clips toward the DIMM until the tabs are fully seated. When the DIMM is correctly installed, the retaining clips are parallel to the sides of the DIMM.

10. Install the air baffle over the DIMM connector.

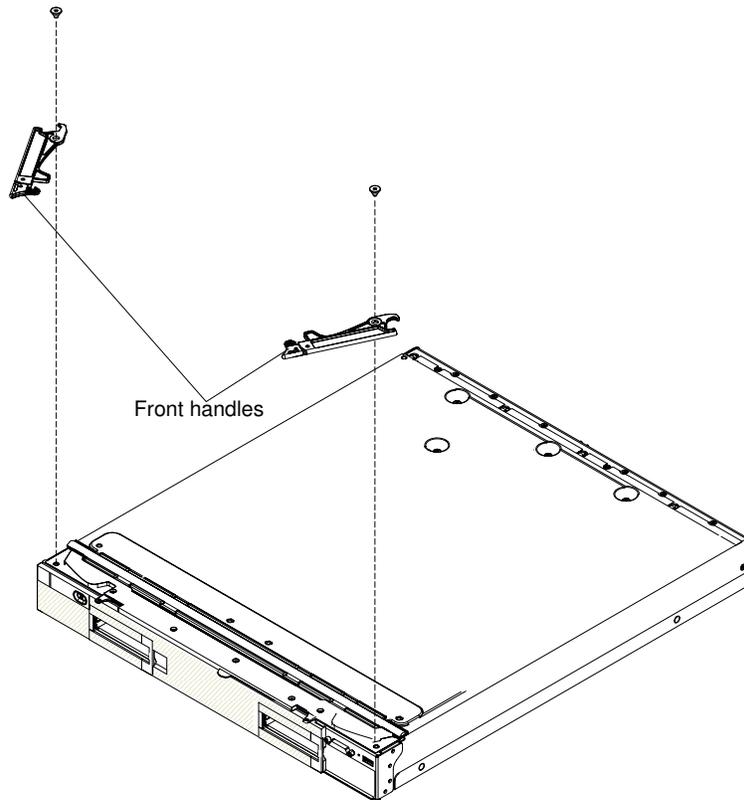
To remove the front handles, complete the following steps.

1. Locate the screws that attach the handles to the compute node.
2. Using a T8 Torx screwdriver, remove the screw from each front handle and save the screw in a safe place. Use the same screws when you install the front handles.

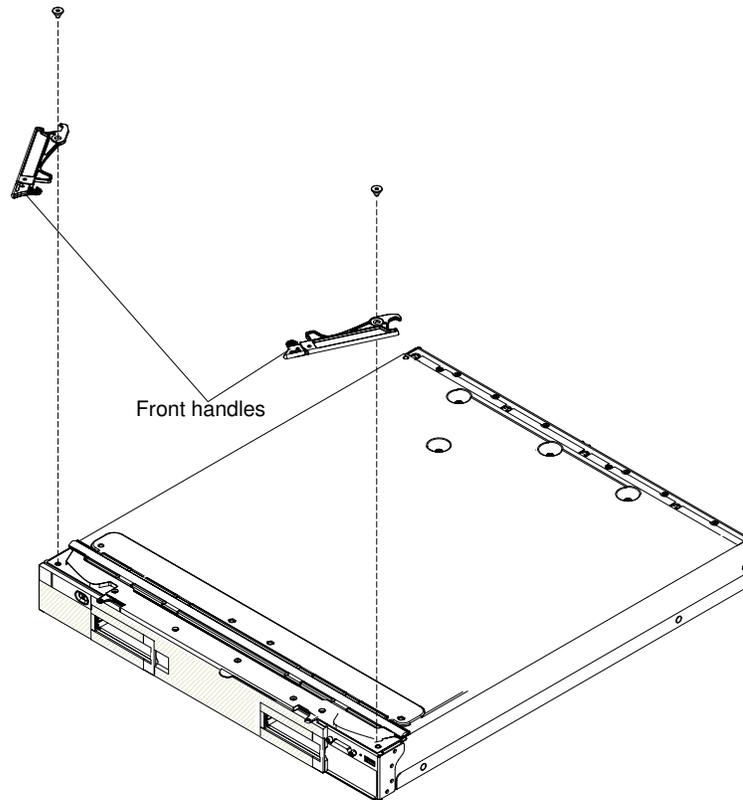
To install the front handles, complete the following steps.

1. Orient the front handles so that the blue release latches are toward the middle of the compute node.
2. Align the hole in the handles with the holes on the compute node where the handles are installed.
3. Using a T8 Torx screwdriver, install the screw that secures each handle. Use the screws that you removed when you removed the handles.

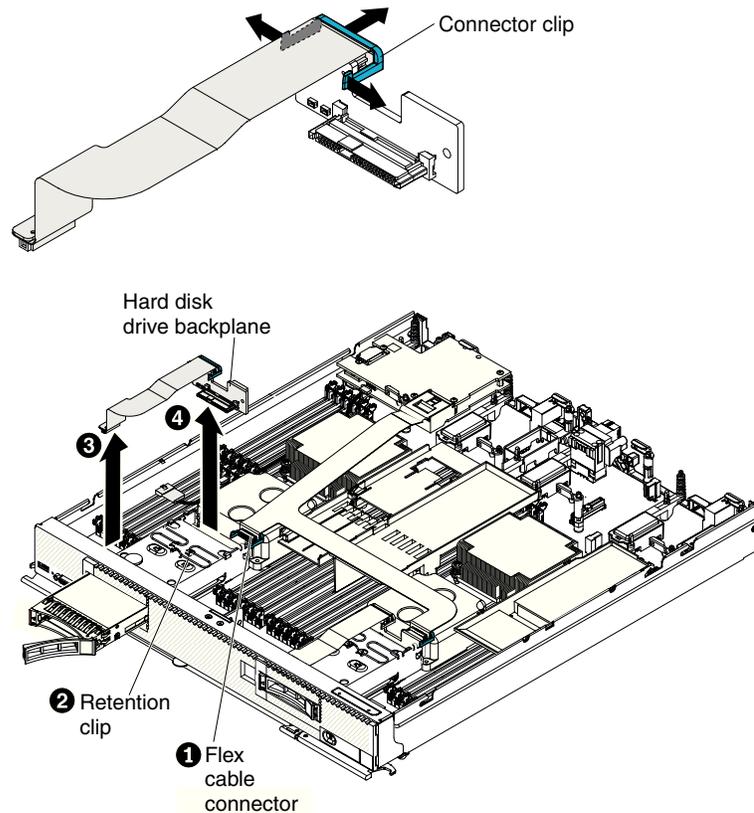
1. Remove the cover (see “Removing the compute node cover” on page 498).
2. For the hard disk drive backplane that you have to replace, disconnect the applicable hard disk drive by pressing the release latch (orange) on the hard disk drive to release the drive handle; then, use the drive handle to slide the hard disk drive approximately 12 mm (0.5 in.) out of the bay. See “Removing a hot-swap hard disk drive” on page 522).
3. To disconnect the cable from the hard disk drive backplane that you removed, pull the connector clip away from the cable to unhook the clip from the backplane as you push the cable connector toward the rear of the compute node **1**.

4. Push the retention clip on the hard disk drive cage toward the rear of the compute node to release it from under the tab; then, slide the retention clip toward the front of the compute node to release the hard disk drive backplane **2**.
5. Disconnect the hard disk drive backplane cable from the system board **3**.
6. Lift out the hard disk drive backplane and cable. It might be necessary to pull the backplane toward the front of the compute node before you lift it out of the compute node **4**.

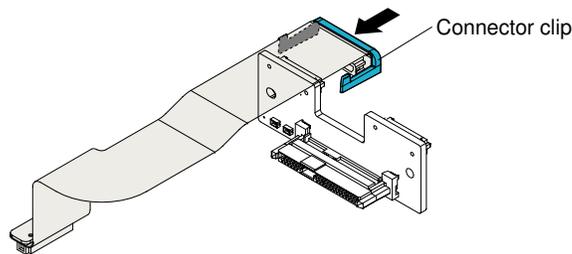
1. Remove the cover (see “Removing the compute node cover” on page 498).
2. To connect the backplane cable to the new hard disk drive backplane, hold open the connector clip while you push the cable connector into the backplane cable connector. Make sure that the connector clip clicks into place around the backplane.

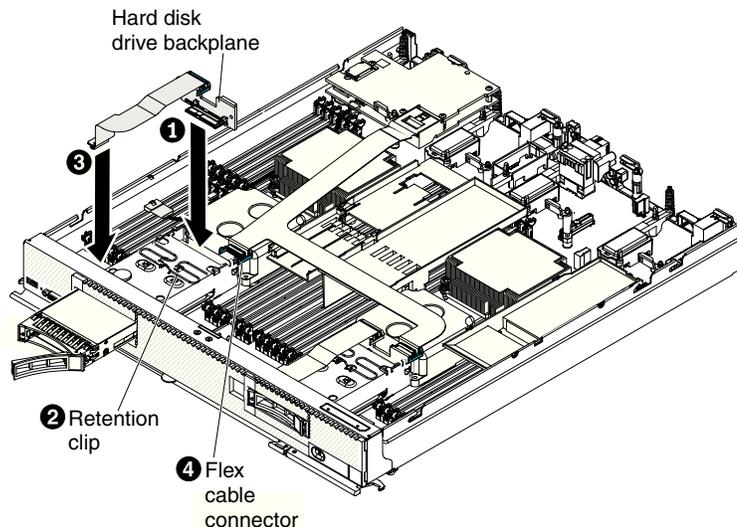
3. Align the new hard disk drive backplane with the hard disk drive cage and the connector on the system board and press the backplane into position until it is fully seated in the connector **1**.

4. Push the retention clip on the hard disk drive cage toward the rear of the compute node and under the tab to secure the backplane **2**.
5. Connect the hard disk drive backplane cable to the system board **3**.
6. Connect the flex cable to the hard disk drive backplane connector.
7. Reconnect the hard disk drive by sliding it fully into the bay and closing the drive tray handle, see "Installing a hot-swap hard disk drive" on page 523
8. Install the cover onto the compute node (see "Installing the compute node cover" on page 500 for instructions).
9. Install the compute node into the chassis (see "Installing a compute node in a chassis" on page 490 for instructions).

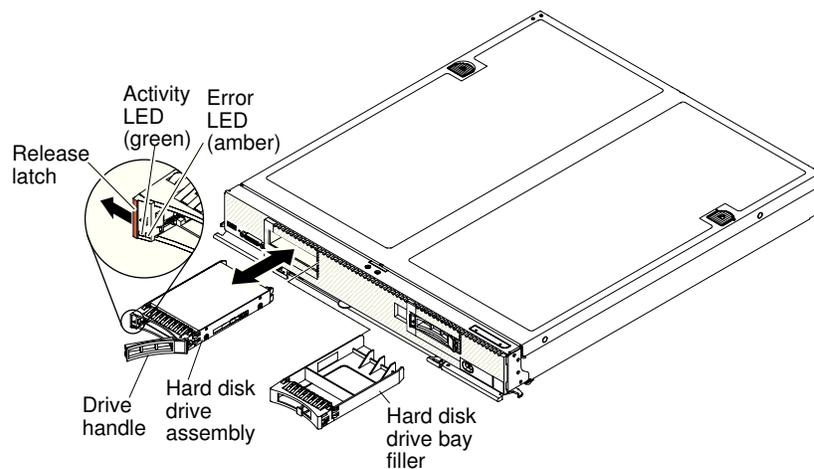
The compute node has two hard disk drive bays for installing or removing hot-swap hard disk devices. To remove a hot-swap hard disk drive, complete the following steps.

1. Press the release latch (orange) on the hard disk drive to release the drive handle.
2. Pull the release handle to remove the drive from the bay.

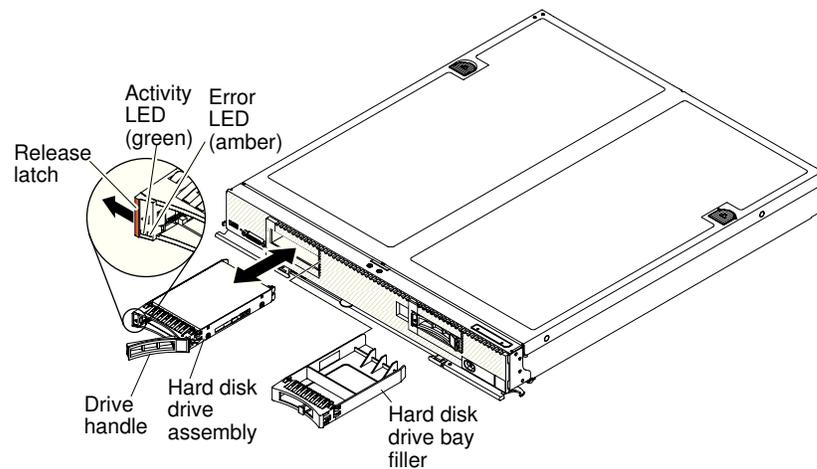
To install a hot-swap hard disk drive or hard disk drive bay filler, complete the following steps.

1. Identify the hard disk drive bay (hard disk drive bay 0 or hard disk drive bay 1) in which you plan to install the hot-swap hard disk drive.
2. If a hard disk drive bay filler is installed, remove it from the compute node by pulling the release lever and sliding the filler away from the compute node.
3. Touch the static-protective package that contains the hot-swap hard disk drive to any *unpainted* metal surface on the IBM Flex System chassis or any *unpainted* metal surface on any other grounded rack component; then, remove the hard disk drive from the package.

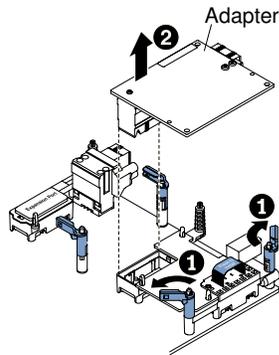
To remove an I/O expansion adapter, complete the following steps.

1. Remove the cover (see “Removing the compute node cover” on page 498).
2. Locate the I/O expansion adapter connectors (see “System-board layouts” on page 16).
3. Open the retention clips **1**.
4. Lift the I/O expansion adapter from the connector and remove the I/O expansion adapter from the compute node **2**. You might find it helpful to rock the adapter back and forth to disengage the adapter.

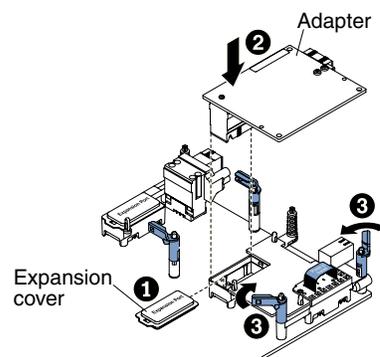
To install an I/O expansion adapter, complete the following steps.

1. Remove the cover (see “Removing the compute node cover” on page 498).
2. Locate the I/O expansion connectors (see “System-board connectors” on page 16).
3. Remove the expansion cover **1** from the connector, if one is present.
4. Touch the static-protective package that contains the adapter to any *unpainted* metal surface on the IBM Flex System chassis or any *unpainted* metal surface on any other grounded rack component; then, remove the adapter from the package.
5. Open the retention clips if they are closed.
6. Orient the connector on the expansion adapter with the I/O expansion connector and alignment pins on the system board **2**; then, press the adapter into the I/O expansion connector.
7. Firmly press on the indicated locations to seat the expansion adapter in the connector and over the alignment pins.
8. Close the retention clips **3**.

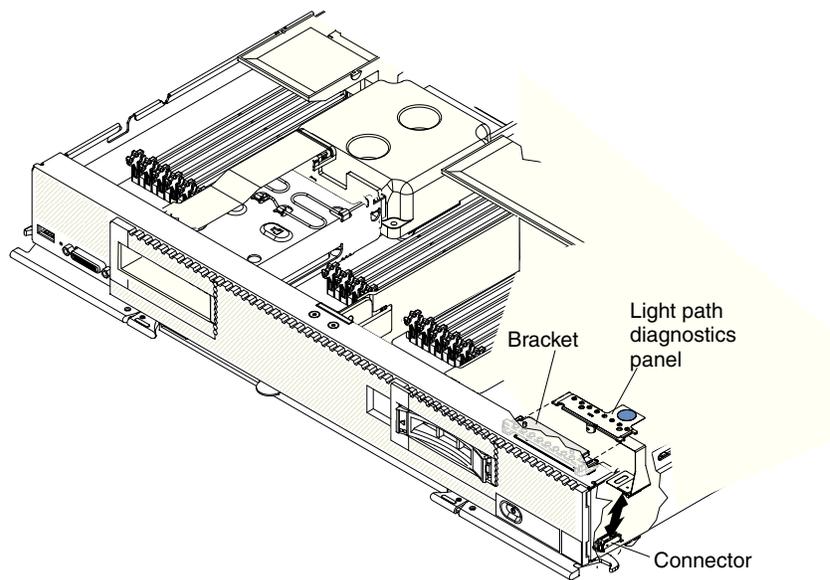
To remove the light path diagnostics panel, complete the following steps.

1. Remove the cover (see “Removing the compute node cover” on page 498).
2. Pull the light path diagnostics panel out of the bracket.
3. Disconnect the cable from the system board.
4. Lift the light path diagnostics panel from the compute node.

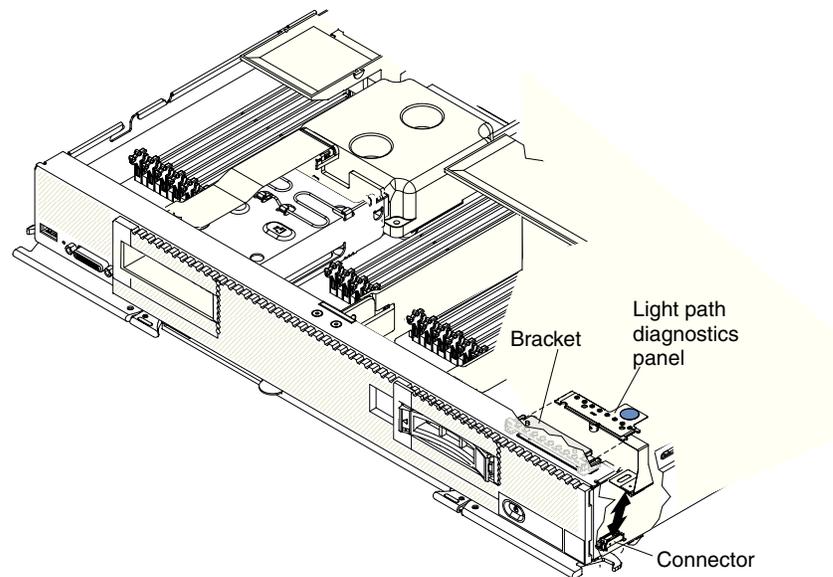
To install a light path diagnostics panel, complete the following steps.

1. Remove the cover (see “Removing the compute node cover” on page 498).
2. Connect the cable on the system board.
3. Align the light path diagnostics panel with the bracket.
4. Press the light path diagnostics panel securely in the bracket.

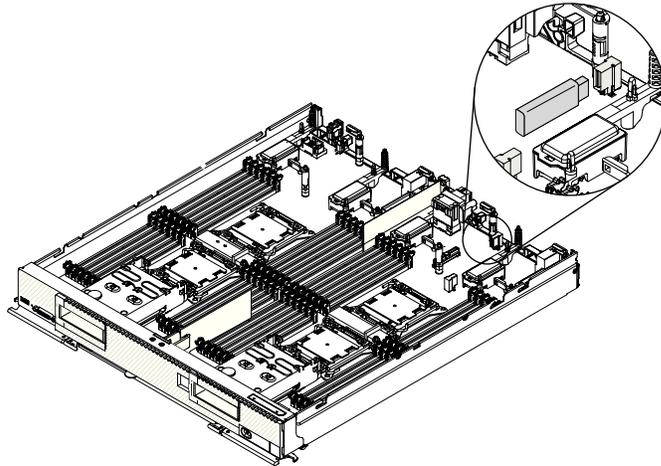
To remove the USB flash drive, complete the following steps.

1. Remove the cover (see "Removing the compute node cover" on page 498).
2. Locate the USB connectors on the system.

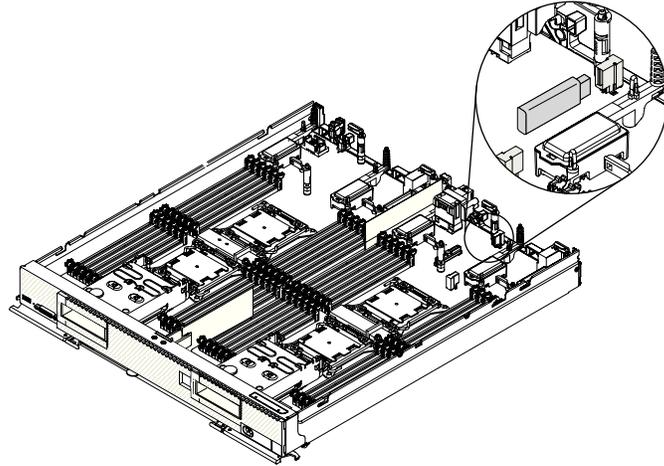
To install the USB flash drive, complete the following steps.

1. Remove the cover (see “Removing the compute node cover” on page 498).
2. Locate the USB connectors on the system board.

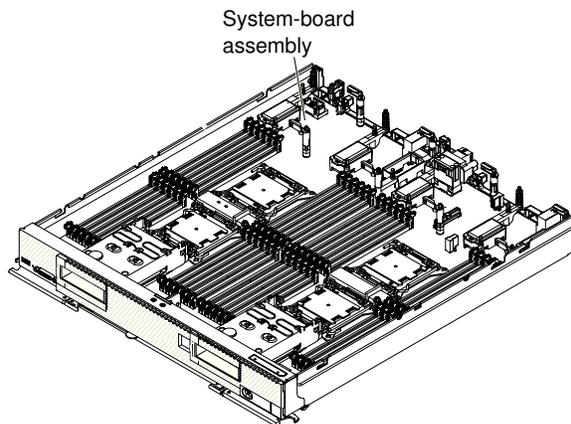
To remove the components from the system board, complete the following steps:

1. Remove the cover (see “Removing the compute node cover” on page 498).
2. Remove all of the installed components in the following list from the system-board assembly; then, place them on a static-protective surface or install them on the new system-board assembly.
 - DIMMs and air baffles (see “Removing a DIMM” on page 501).
 - I/O expansion adapters (see “Removing an I/O expansion adapter” on page 524).

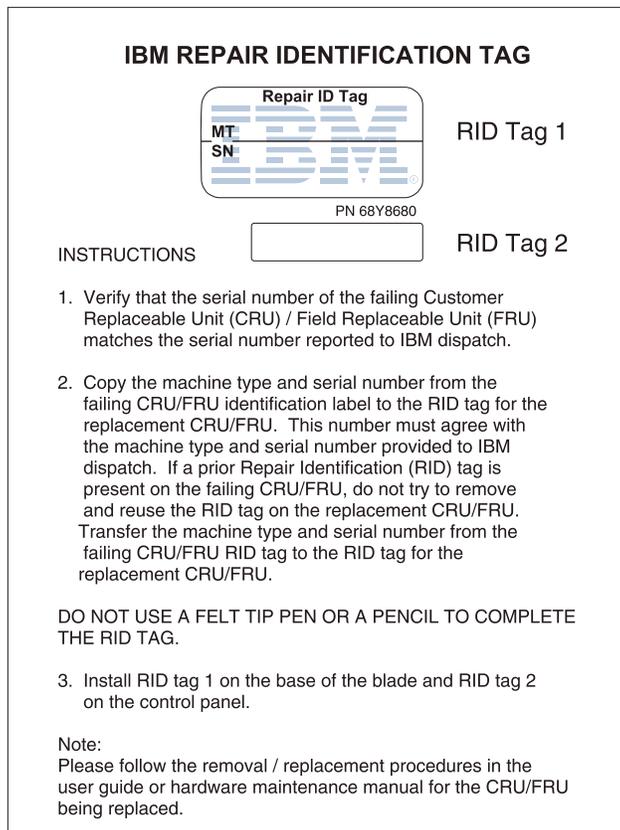
- Hard disk drives and hard disk drive bay fillers (see “Removing a hot-swap hard disk drive” on page 522).
- Microprocessors, heat sinks, and microprocessor heat sink fillers. Use the microprocessor installation tool that comes with the CRU kit to remove each microprocessor from the system-board assembly and install each one immediately in the new system-board assembly (see “Removing a microprocessor and heat sink” on page 539 and “Installing a microprocessor and heat sink” on page 542).
- Hard disk drive backplane (see “Removing the hard disk drive backplane” on page 519).

3. The new base assembly comes with an IBM Repair Identification (RID) tag on the system board. Using a ball point pen, transfer the machine type and serial number from the old system board to the two labels on the IBM Repair Identification (RID) tag that comes with the new system board; then, place label 1 (larger label) on the base of the system board and label 2 (smaller label) on the bottom side of the control panel.

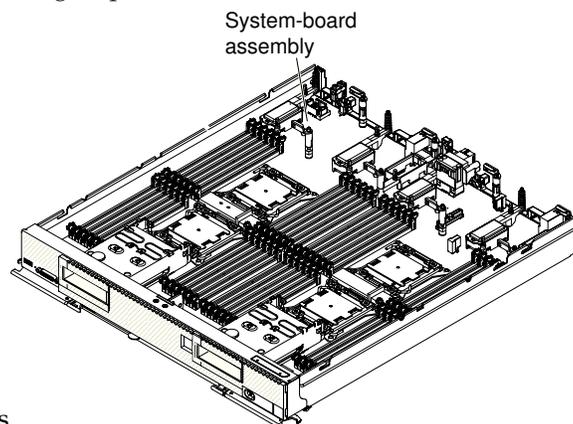
To install the components on the system board of the new base assembly, complete the following steps.

1. Install all of the components in the following list that you removed from the old system board onto the new system board.
 - DIMMs and air baffles (see “Installing a DIMM” on page 502).
 - I/O expansion adapters (see “Installing an I/O expansion adapter” on page 525).
 - Hard disk drives and hard disk drive fillers (see “Installing a hot-swap hard disk drive” on page 523).
 - Microprocessors, heat sinks, and microprocessor heat sink fillers. Use the microprocessor installation tool that comes with the CRU kit to remove each microprocessor from the system board and install each one immediately in the new system board (see “Removing a microprocessor and heat sink” on page 539 and “Installing a microprocessor and heat sink” on page 542).

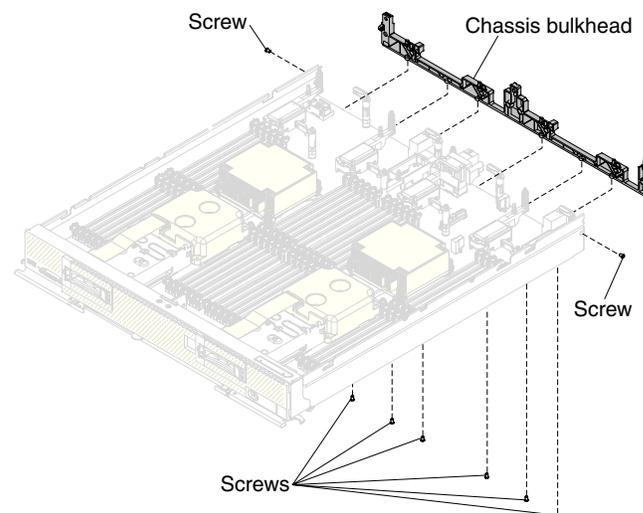
To remove the chassis bulkhead, complete the following steps.

1. Remove the cover (see “Removing the compute node cover” on page 498).
2. Remove the fabric connector (see “Removing a fabric connector” on page 537).
3. Carefully place the chassis on its side with the front handle side up.

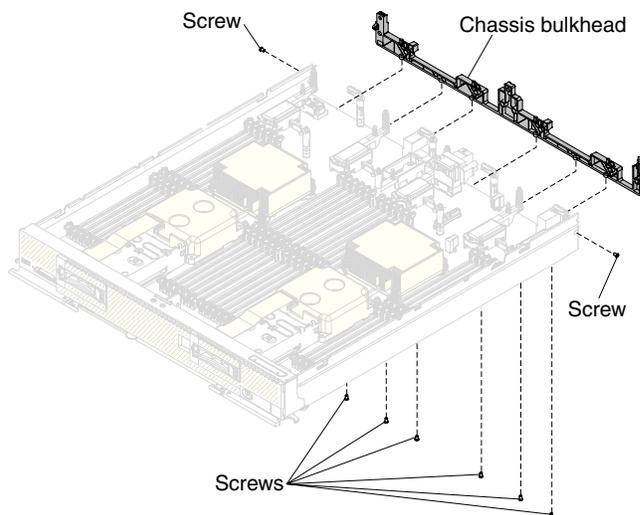
To install the chassis bulkhead, complete the following steps.

2. Remove the fabric connector (see “Removing a fabric connector” on page 537).
3. Position the bulkhead in the chassis.
4. Using a T8 Torx screwdriver, install the screws that secure the bulkhead to the sides of the chassis.
5. Carefully place the chassis on its side with the front handle side up.
6. Using a T8 Torx screwdriver, install the screws that secure the bulkhead to the bottom of the chassis.
7. Carefully return the chassis to the bottom-side-down orientation.
8. Install the fabric connector (see “Installing a fabric connector” on page 538).
9. Install the air baffles, if you removed them.

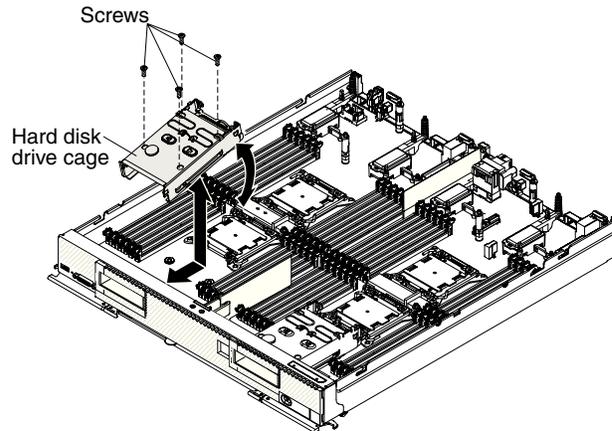
To remove the hard disk drive cage, complete the following steps.

1. Remove the cover (see “Removing the compute node cover” on page 498).
2. Remove the hot-swap hard disk drives and hard disk drive bay fillers (see “Removing a hot-swap hard disk drive” on page 522).
3. Remove the hard disk drive backplane (see “Removing the hard disk drive backplane” on page 519).
4. Using a T8 Torx screwdriver, remove the four screws from the cage and rotate the cage from under the bezel; then, remove the cage from the compute node at an angle.
