IBM Flex System x440 Compute Node
Types 7917 and 2584
Installation and Service Guide

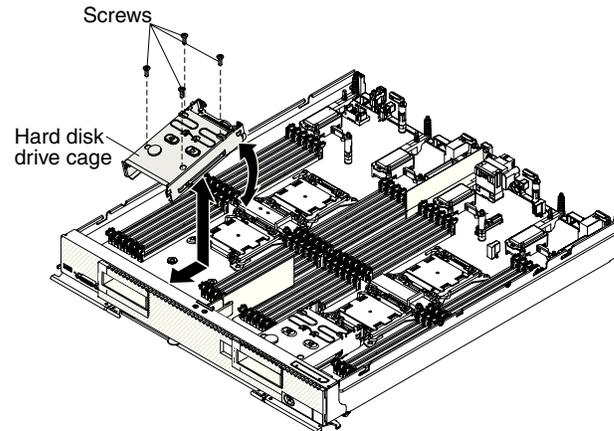
To install the hard disk drive cage, complete the following steps.

1. Remove the cover (see “Removing the compute node cover” on page 498).
2. Position the cage in the bezel at an angle and rotate the cage into position on the system board.
3. Align the cage with the screw holes on the system board.
4. Using a T8 Torx screwdriver, install the four screws and secure the cage in the compute node.
5. Install the hard disk drive backplane (see “Installing the hard disk drive backplane” on page 521).
6. Insert the hot-swap hard disk drives and hard disk drive bay fillers (see “Installing a hot-swap hard disk drive” on page 523).

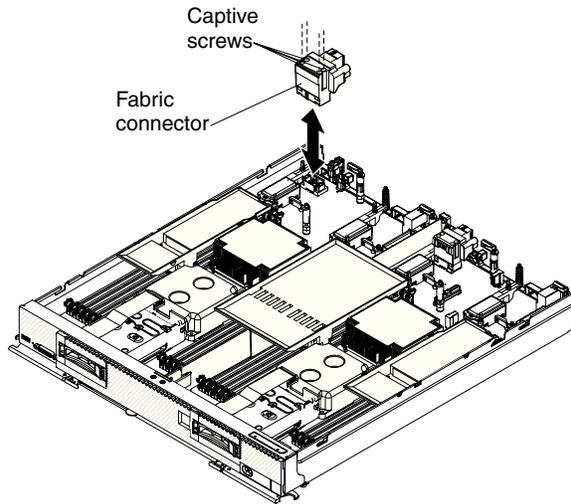
To remove a fabric connector, complete the following steps.

1. Remove the cover (see “Removing the compute node cover” on page 498).
2. Locate the fabric connector on the system board.
3. Using a Phillips #1 screwdriver, loosen the four captive screws that secure the fabric connector.
4. Lift the fabric connector from the system board and store it in a safe place.

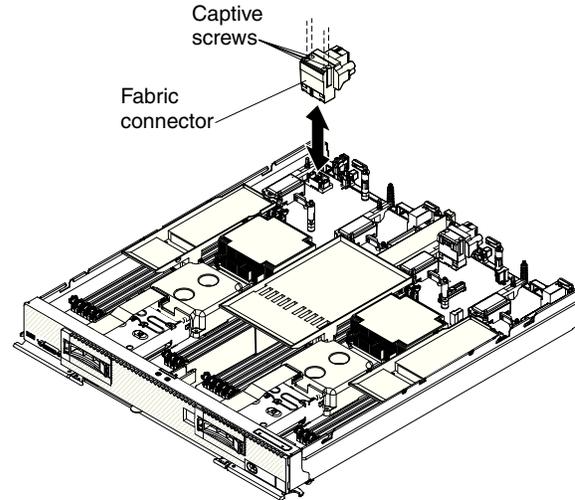
To install a fabric connector, complete the following steps.

- Remove the cover (see “Removing the compute node cover” on page 498).
- Locate the fabric connector (see “System-board layouts” on page 16).
- Orient the fabric connector on the system board.
- Using a Phillips #1 screwdriver, tighten the four captive screws to secure the fabric connector.

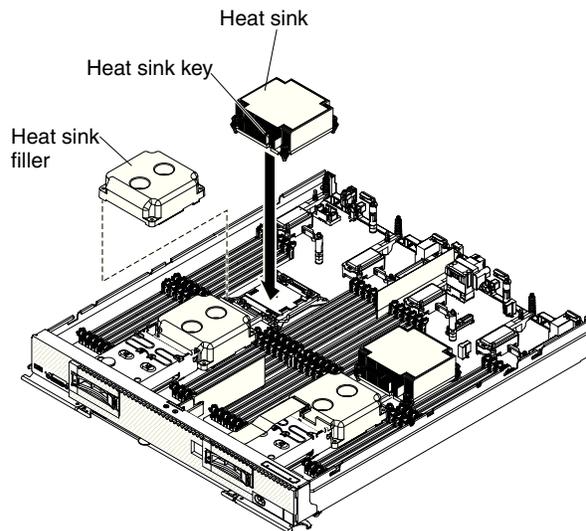
To remove a microprocessor and heat sink, complete the following steps.

1. Remove the cover (see "Removing the compute node cover" on page 498).
2. Locate the microprocessor that is to be removed (see "System-board connectors" on page 16).
3. Remove the heat sink.

- a. Use a screwdriver to loosen the screw on one side of the heat sink to break the seal with the microprocessor.
- b. Use a screwdriver to loosen the screws on the heat sink, rotating each screw two full turns until each screw is loose.
- c. Gently pull the heat sink from the microprocessor.

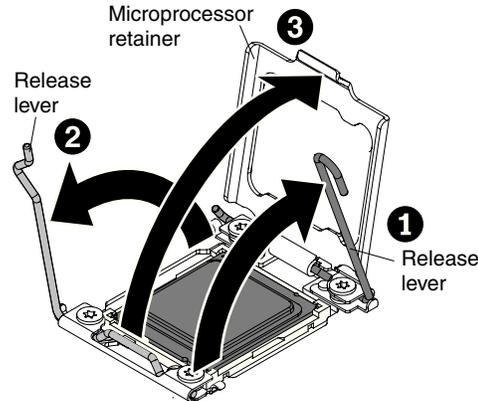
4. Open the microprocessor socket release levers and retainer.

- a. Identify which release lever is labeled as the first release lever to open, and open it.
- b. Open the second release lever on the microprocessor socket.
- c. Open the microprocessor retainer.

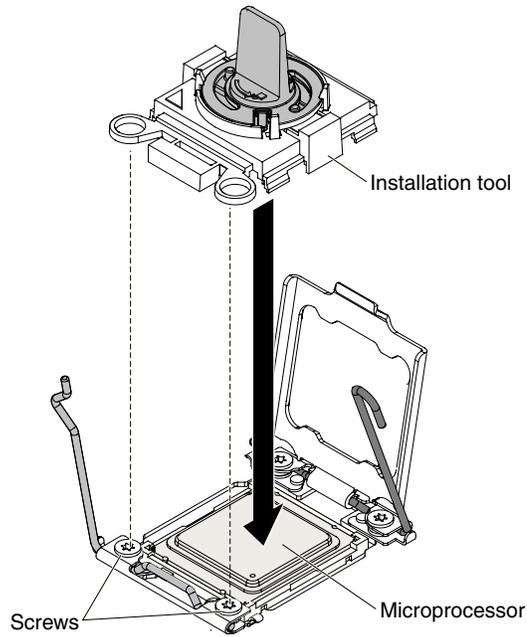
- b. Align the installation tool with the screws on the microprocessor socket, and lower the tool on the microprocessor. The installation tool rests flush on the socket only if it is aligned correctly.

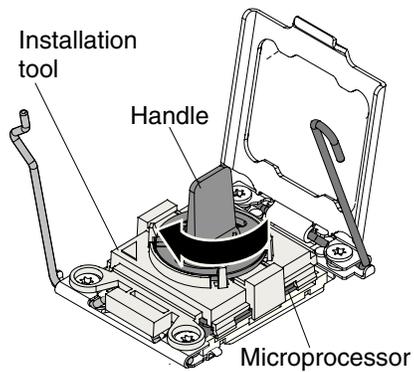
- c. Twist the handle on the installation tool clockwise and lift the microprocessor out of the socket.

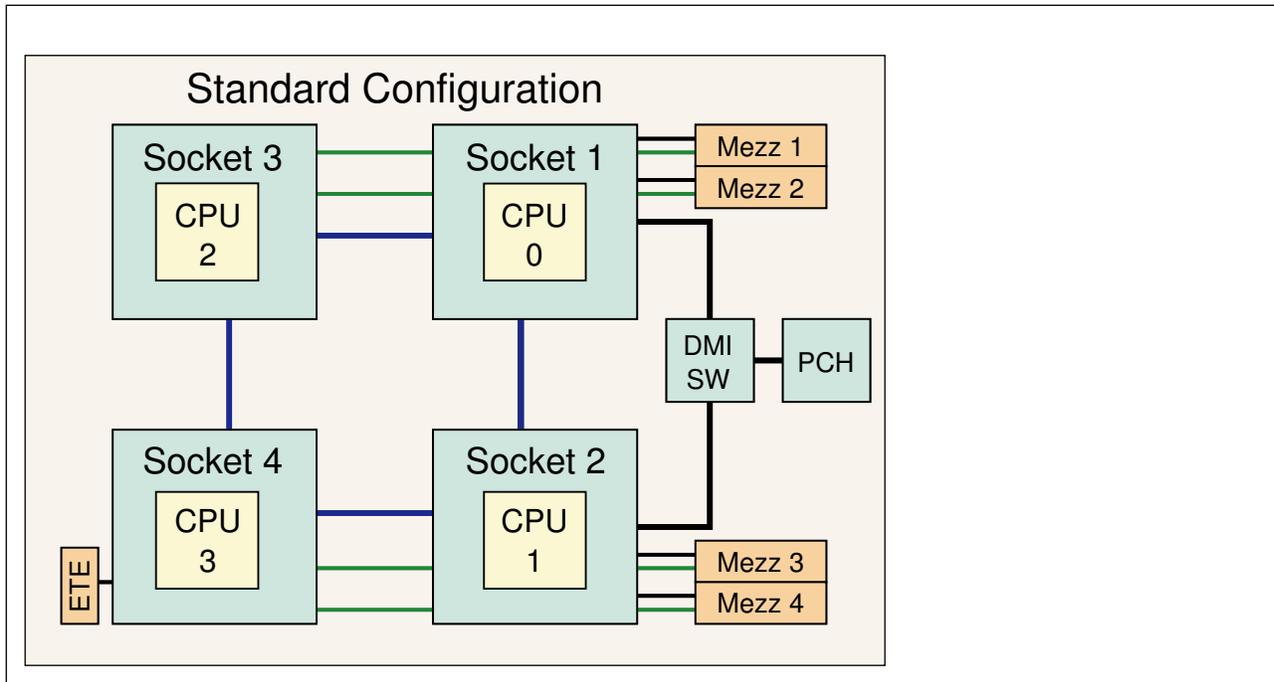
Figure 1. Standard Configuration

The architecture of the Intel Sandy Bridge-EP 4S and DMI switching of microprocessor sockets 1 and 2 allow for the processors to be populated as shown in the following figures.

1. CPU0 is the boot strap processor.
2. Combinations highlighted in **bold** represent the default configurations, which should be used when processors are installed during manufacturing. The other combinations shown in the table are supported in the event of an error.
3. If a bad processor in microprocessor socket 1 causes the processor installed in microprocessor socket 2 to become the boot strap processor and is subsequently replaced, the processor ordering reverts to the default CPU IDs for the new number of CPUs, because the FPGA would not hold the last CPU ID assignments and "add in" the replaced processor.
4. Three-processor configurations are not supported.
5. A microprocessor failure in a four-processor configuration will result in the system failing down to three functional microprocessor.

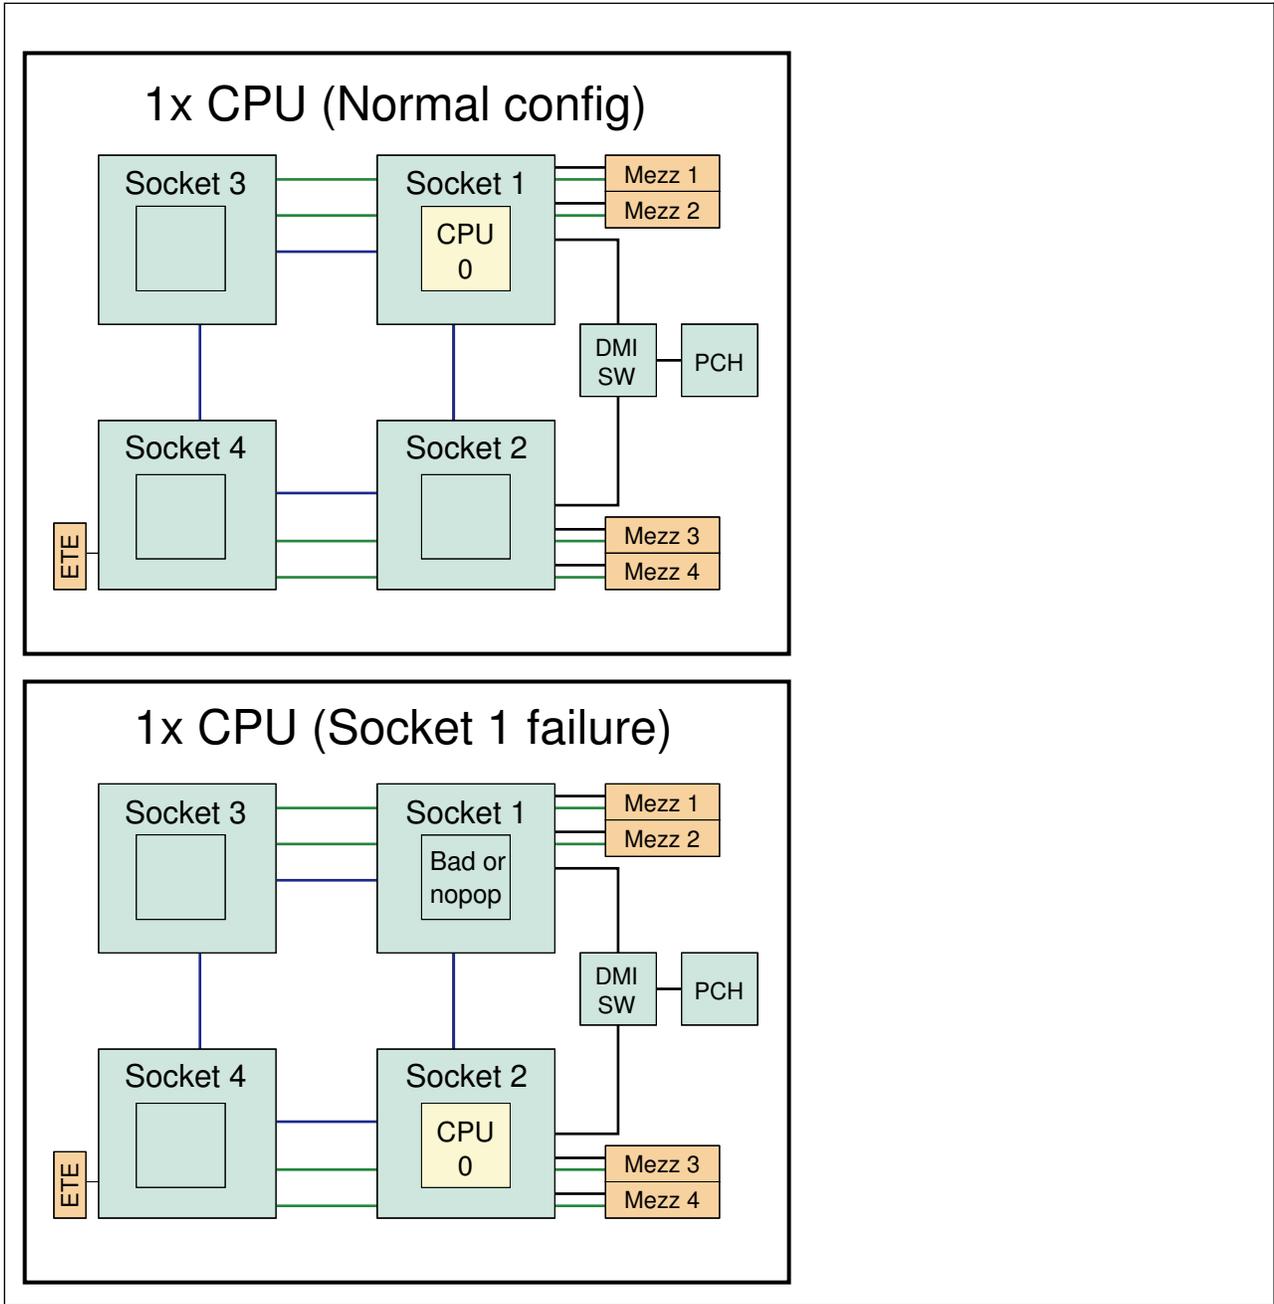
Figure 2. Supported one CPU configuration

The supported microprocessor configurations are shown in the following illustrations.

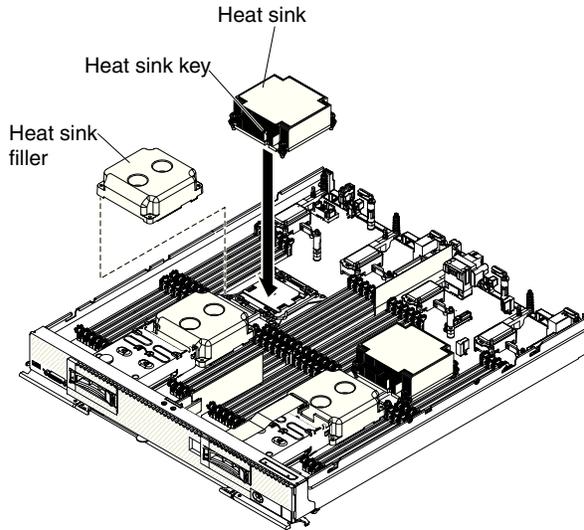
1. Remove the cover (see “Removing the compute node cover” on page 498).
2. If you are not installing a new microprocessor and a new heat sink, remove the thermal grease from the heat sink and microprocessor; then, apply new thermal grease before installation (see “Thermal grease” on page 551).
3. Remove the heat-sink filler, if one is present.
4. Open the microprocessor socket release levers and retainer.

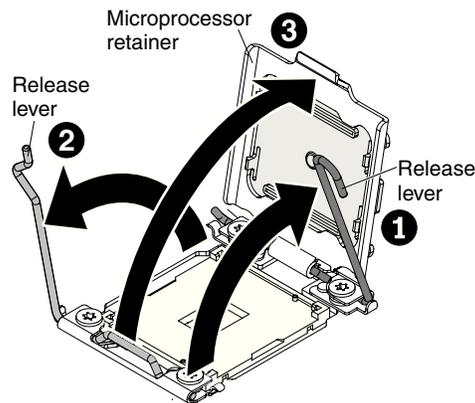
- a. Identify which release lever is labeled as the first release lever to open and open it.
 - b. Open the second release lever on the microprocessor socket.
 - c. Open the microprocessor retainer.
5. Install the microprocessor on the microprocessor socket:

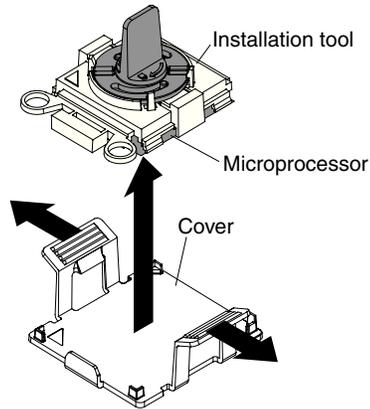
- a. Touch the static-protective bag that contains the new microprocessor to any *unpainted* surface on the IBM Flex System chassis or any *unpainted* metal surface on any other grounded rack component; then, carefully remove the microprocessor and installation tool from the package.
- b. Release the sides of the cover and remove the cover from the installation tool. The microprocessor is preinstalled on the installation tool.

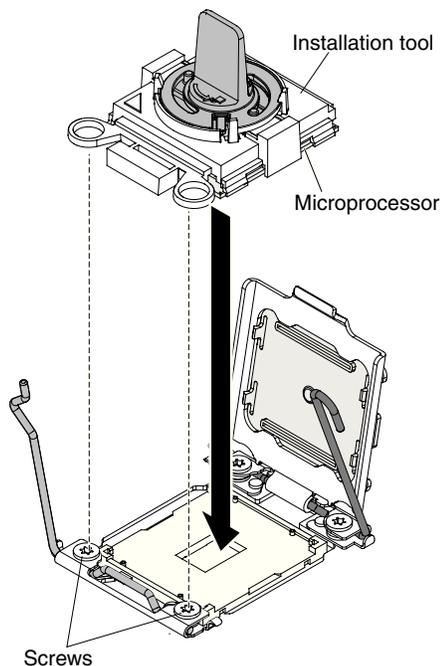
- c. Align the installation tool with the microprocessor socket. The installation tool rests flush on the socket only if it is properly aligned.

- d. Twist the handle on the microprocessor tool counterclockwise to insert the microprocessor into the socket. The microprocessor is keyed to ensure that the microprocessor is installed correctly. The microprocessor rests flush on the socket only if it is properly installed.

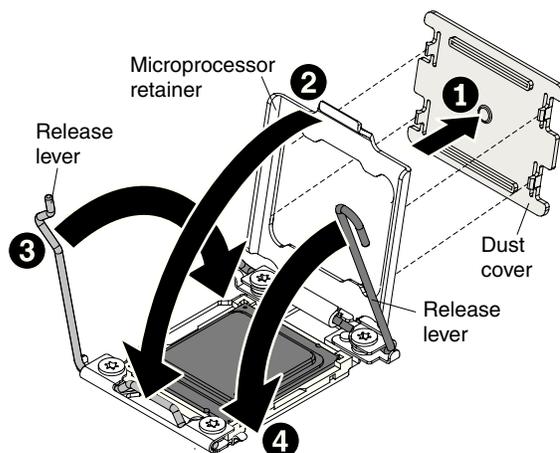
6. Close the microprocessor socket release retainer and levers.

- a. Close the microprocessor retainer on the microprocessor socket.
- b. Identify which release lever is labeled as the first release lever to close, and close it.
- c. Close the second release lever on the microprocessor socket.
- d. If a socket cover is installed over the microprocessor retainer, it is released as you close the retainer. Remove the socket cover from the compute node and store it in a safe place.

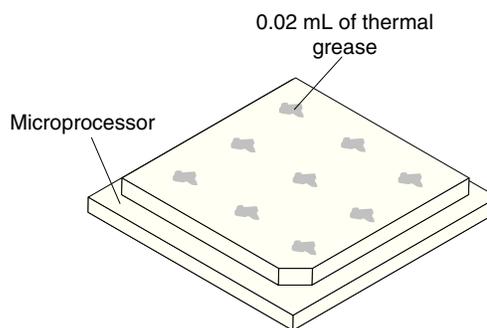
4. Use a clean area of the cleaning pad to wipe the thermal grease from the microprocessor; then, dispose of the cleaning pad after all of the thermal grease is removed.

5. Use the thermal-grease syringe to place nine uniformly spaced dots of 0.02 mL each on the top of the microprocessor.

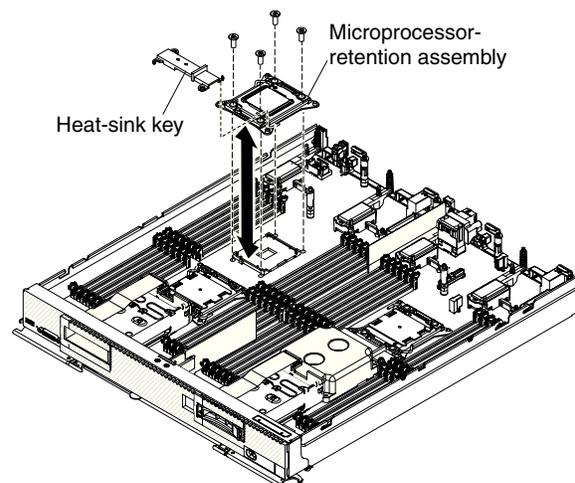
To remove a microprocessor-retention assembly, complete the following steps.

1. Remove the cover (see “Removing the compute node cover” on page 498).
2. Locate the microprocessor socket on the system board.
3. If a microprocessor and heat sink are installed, remove them (see “Removing a microprocessor and heat sink” on page 539).
4. Remove the heat-sink key from the microprocessor-retention assemblies and store it in a safe place.
5. Make sure that the microprocessor socket release levers are in the open position.
6. Using a T20 Torx screwdriver, remove the four screws that secure the microprocessor-retention assembly.

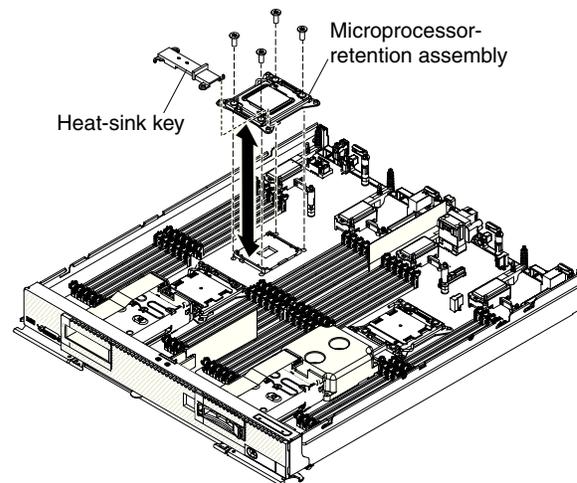
To install a microprocessor-retention assembly, complete the following steps.

1. Remove the cover (see “Removing the compute node cover” on page 498).
2. Make sure that the microprocessor socket release levers are in the open position.
3. Align the microprocessor-retention assembly on the system board.
